# Cochlear<sup>™</sup> Nucleus<sup>®</sup> Implants Magnetic Resonance Imaging (MRI) Guidelines

CI24RE, CI500 and CI600 series implants

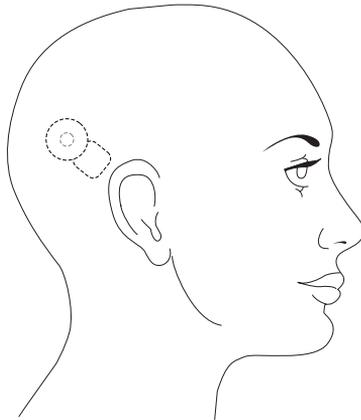
Cochlear Nucleus implants are made of metal and implanted under the skin behind the ear.

Figure 1: Location behind the ear for Cochlear Nucleus implants

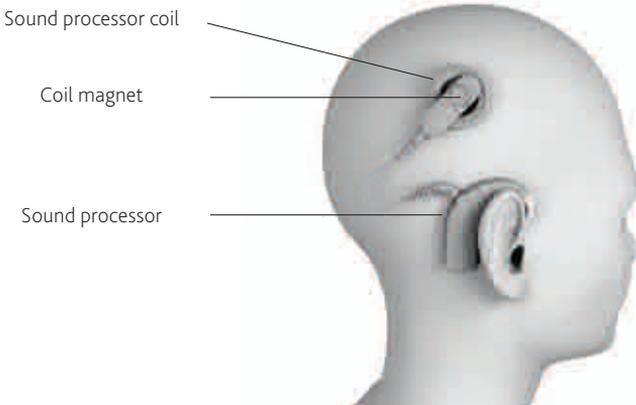
Figure 4: Location of the sound processor, sound processor coil and coil magnet

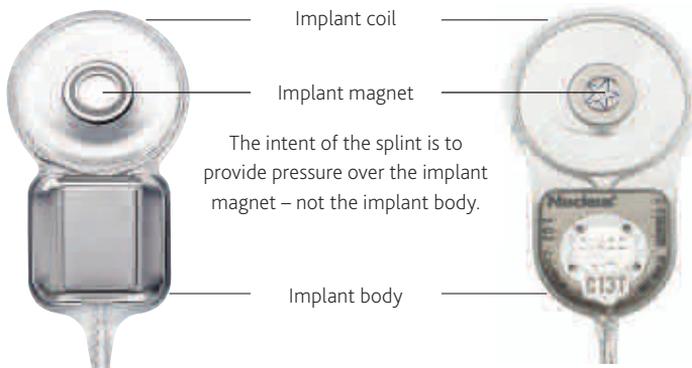
Figure 5: Location of the implant magnet on CI500 Series (left side) and CI24RE Series (right side) implants

1. Use a splint from the MRI Kit and centre it over the implant magnet site (as marked) against the skin. Ensure the splint is held in place over the implant magnet. See *Figure 5: Location of the implant magnet on CI500 Series (left side) and CI24RE Series (right side) implants on page 61* below for the implant magnet location. You may need the assistance of another person to hold the splint in place while you bandage. Otherwise, use the supplied tape to maintain the splint position prior to bandaging.

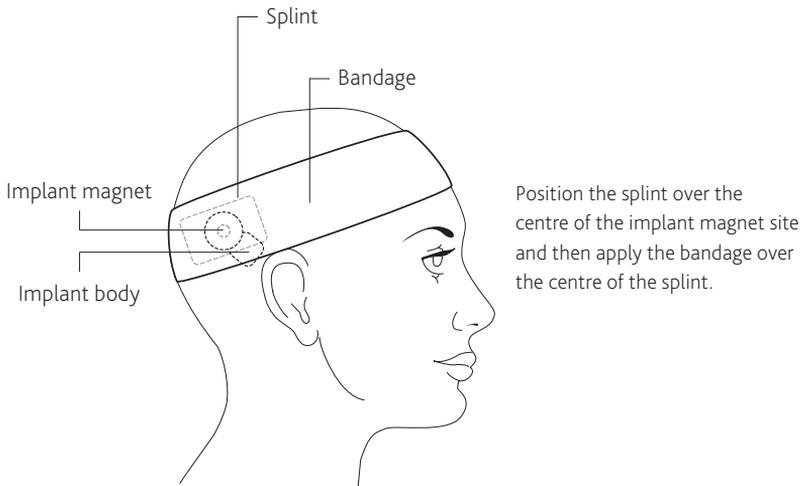
Figure 6: Fitting the MRI Kit splint and compression bandage

2. Use the elasticised compression bandage from the MRI Kit and ensure the centre line of the bandage is over the implant magnet site and the splint is fully covered. See *Figure 6* below.

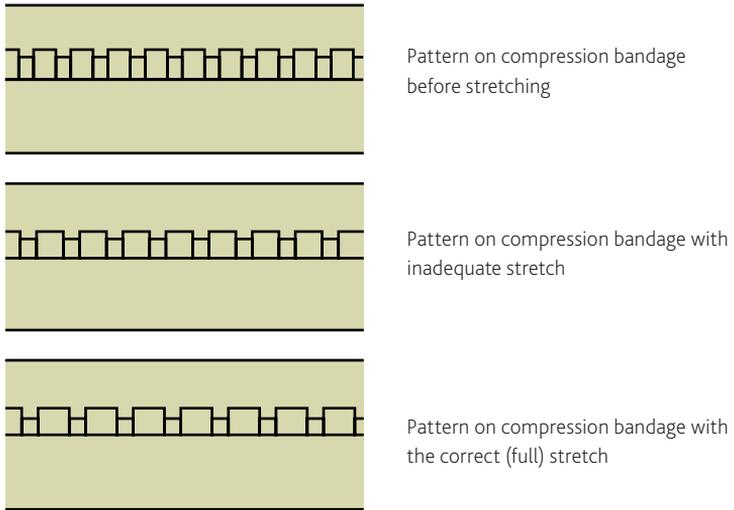
Figure 7: Comparison of compression bandage tightness

- Use a minimum of two bandage layers at full stretch (no elasticity remaining in the bandage). When the bandage is at its maximum tightness, the small rectangular tension markers will stretch to become square in shape. See *Figure 7* below.

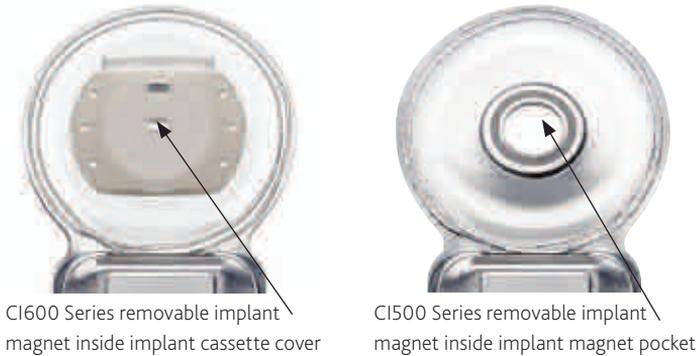
Figure 8: .CI600 and CI500 Series implant with removable magnet
